TOWN OF ELMORE, VT

Monthly Select Board Meeting

WE12 - Worcester Elmore VT Route 12 Public Informational Meeting

VT Route 12 – Elmore Bridges #90 & 94

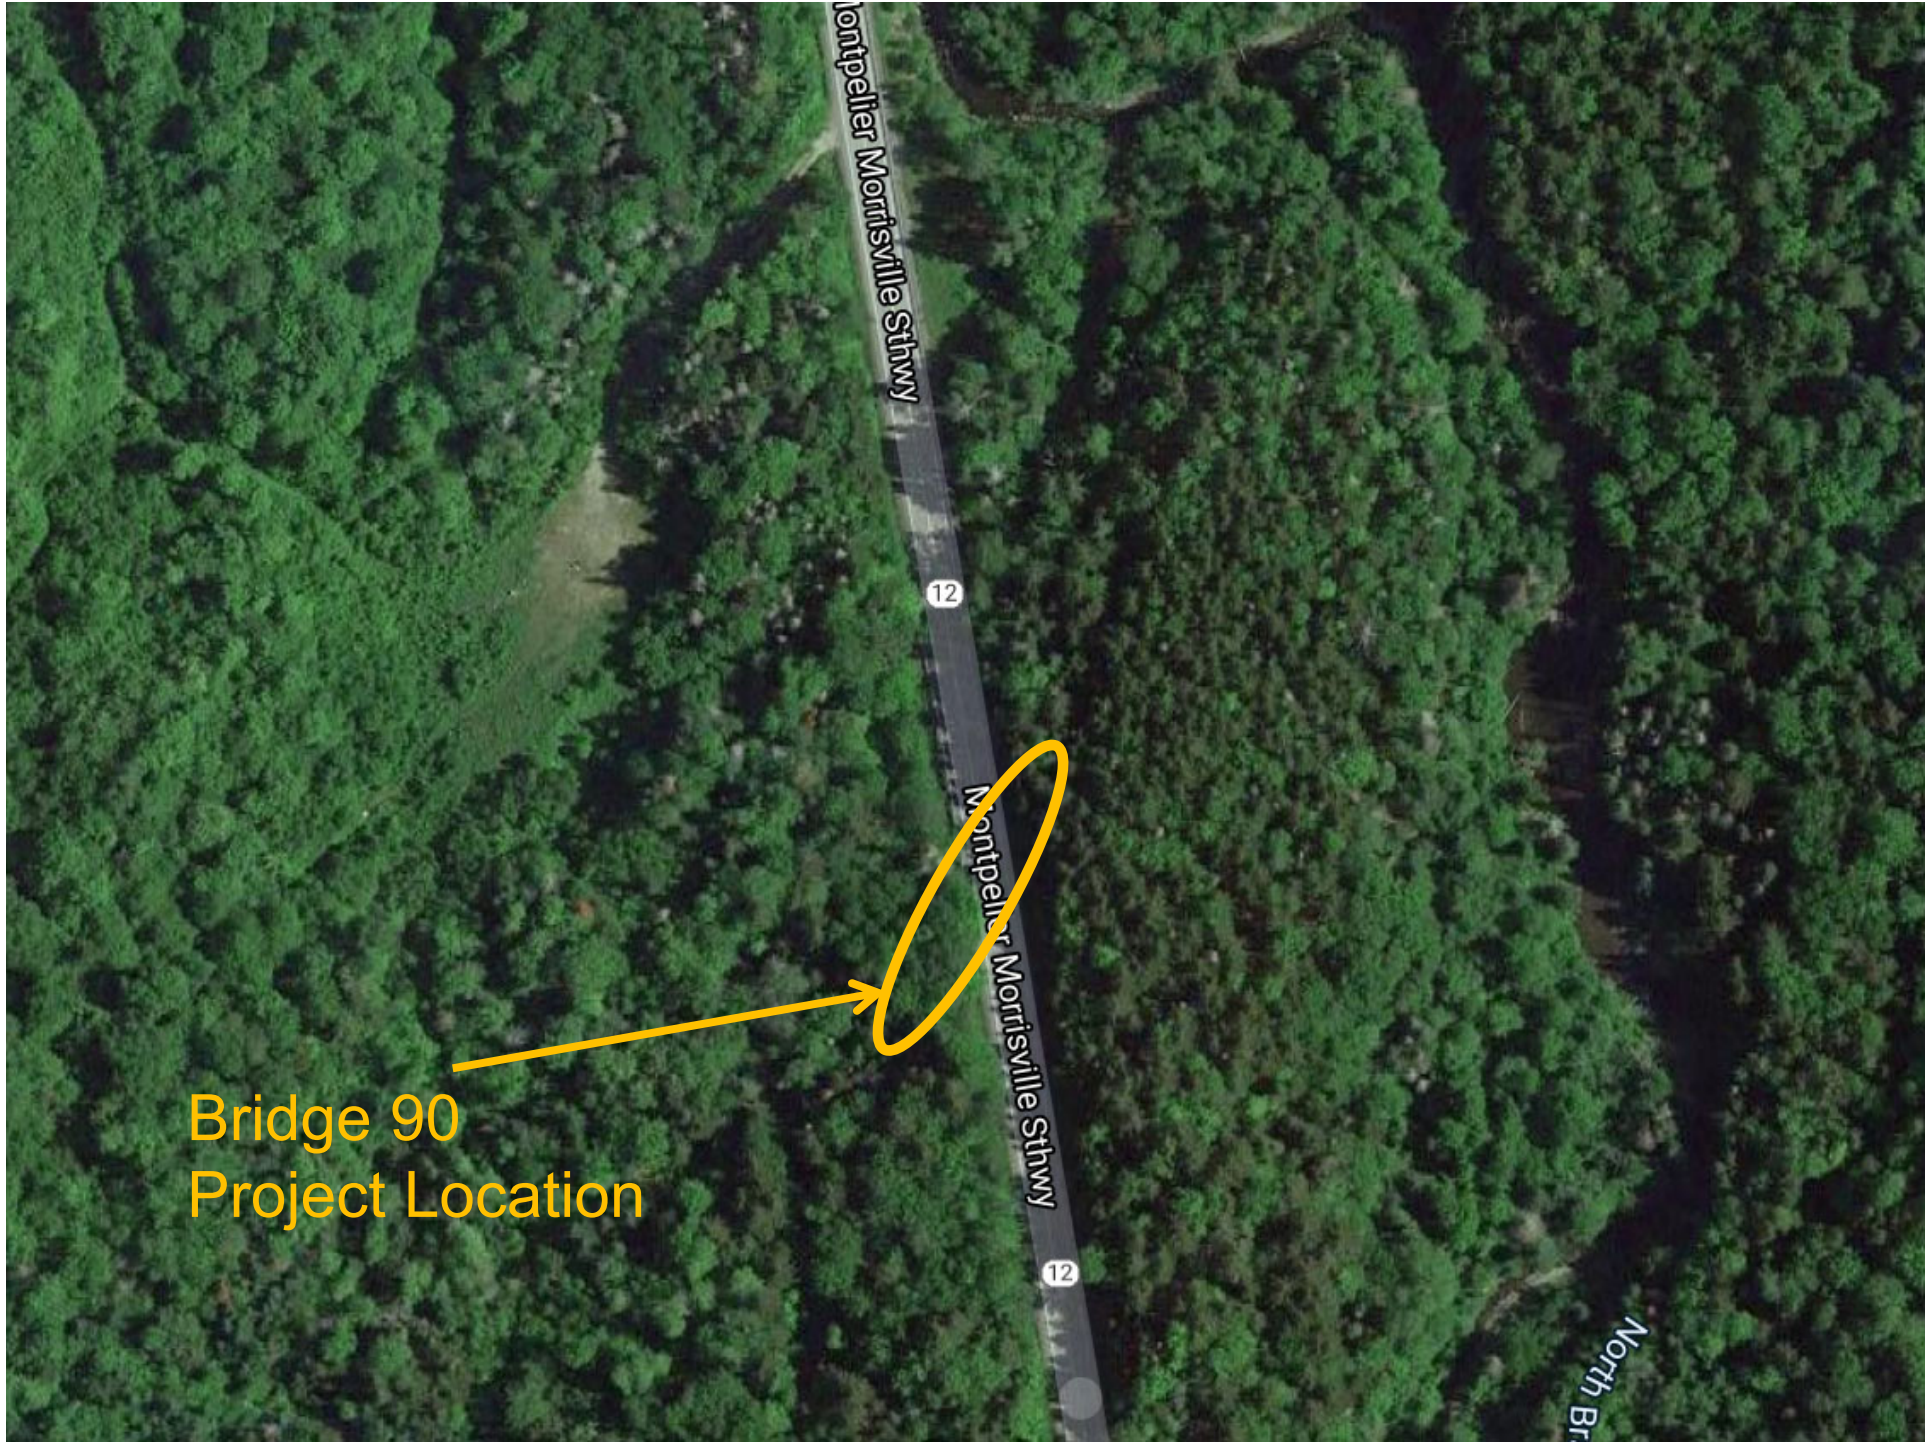
Bridge 90
Project Location

Looking North over Bridge 90

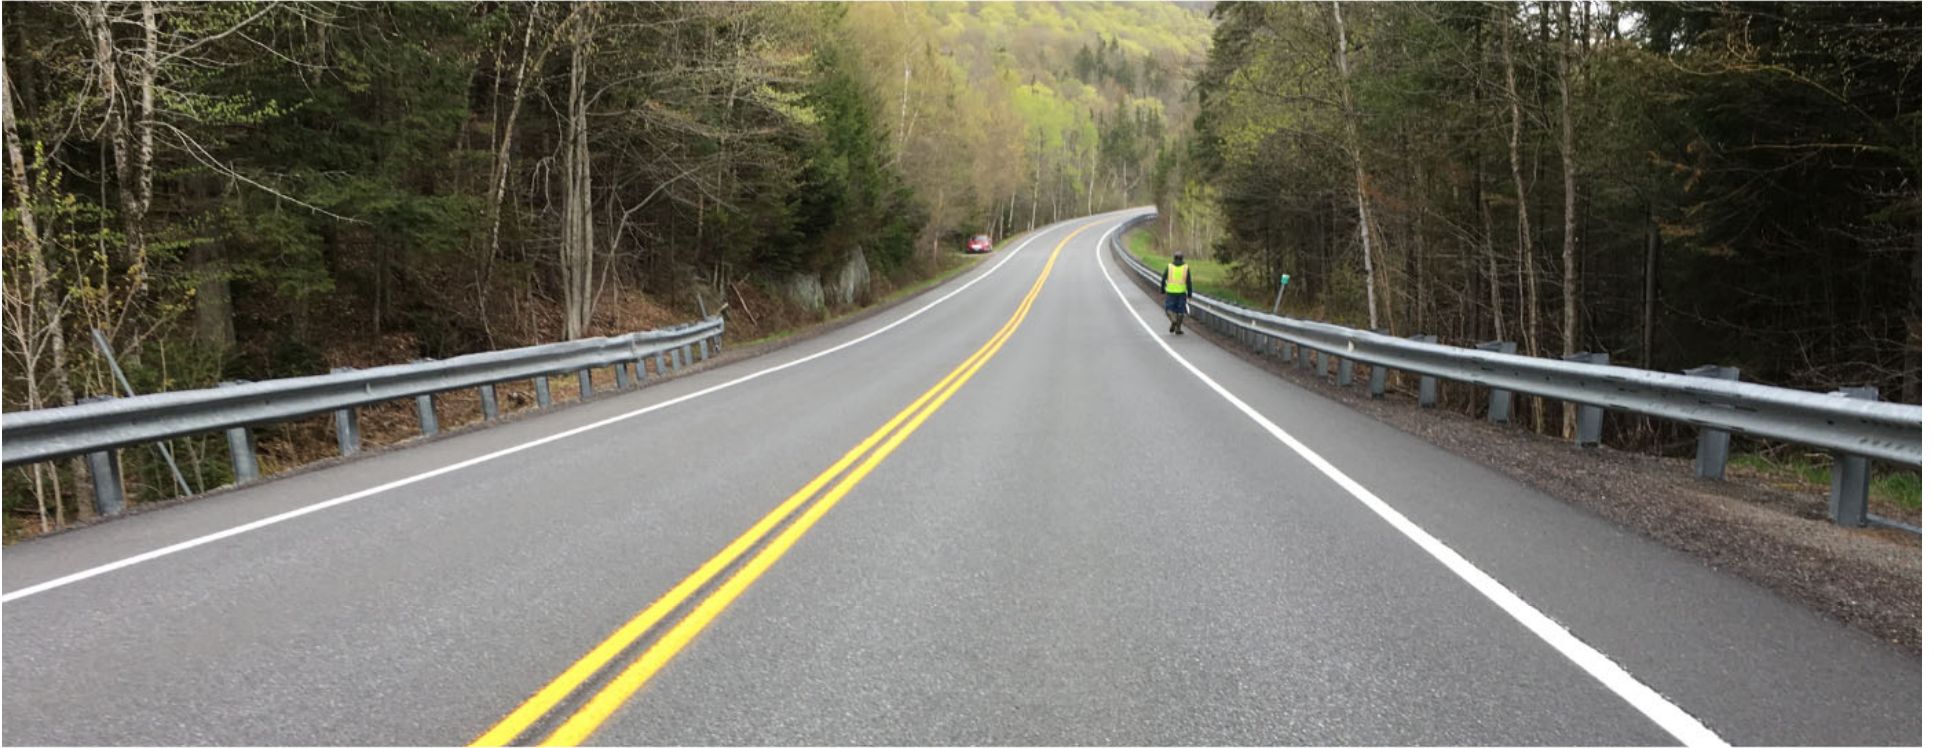
Existing Conditions – Bridge #90

- Roadway Classification – Major Collector
- Bridge Type – 6' Span CGMPP (Corrugated Galvanized Metal Plate Pipe)
- Culvert Length – 208 feet
- Fill Over Culvert – 18 feet
- Ownership – State of Vermont
- Constructed in 1964

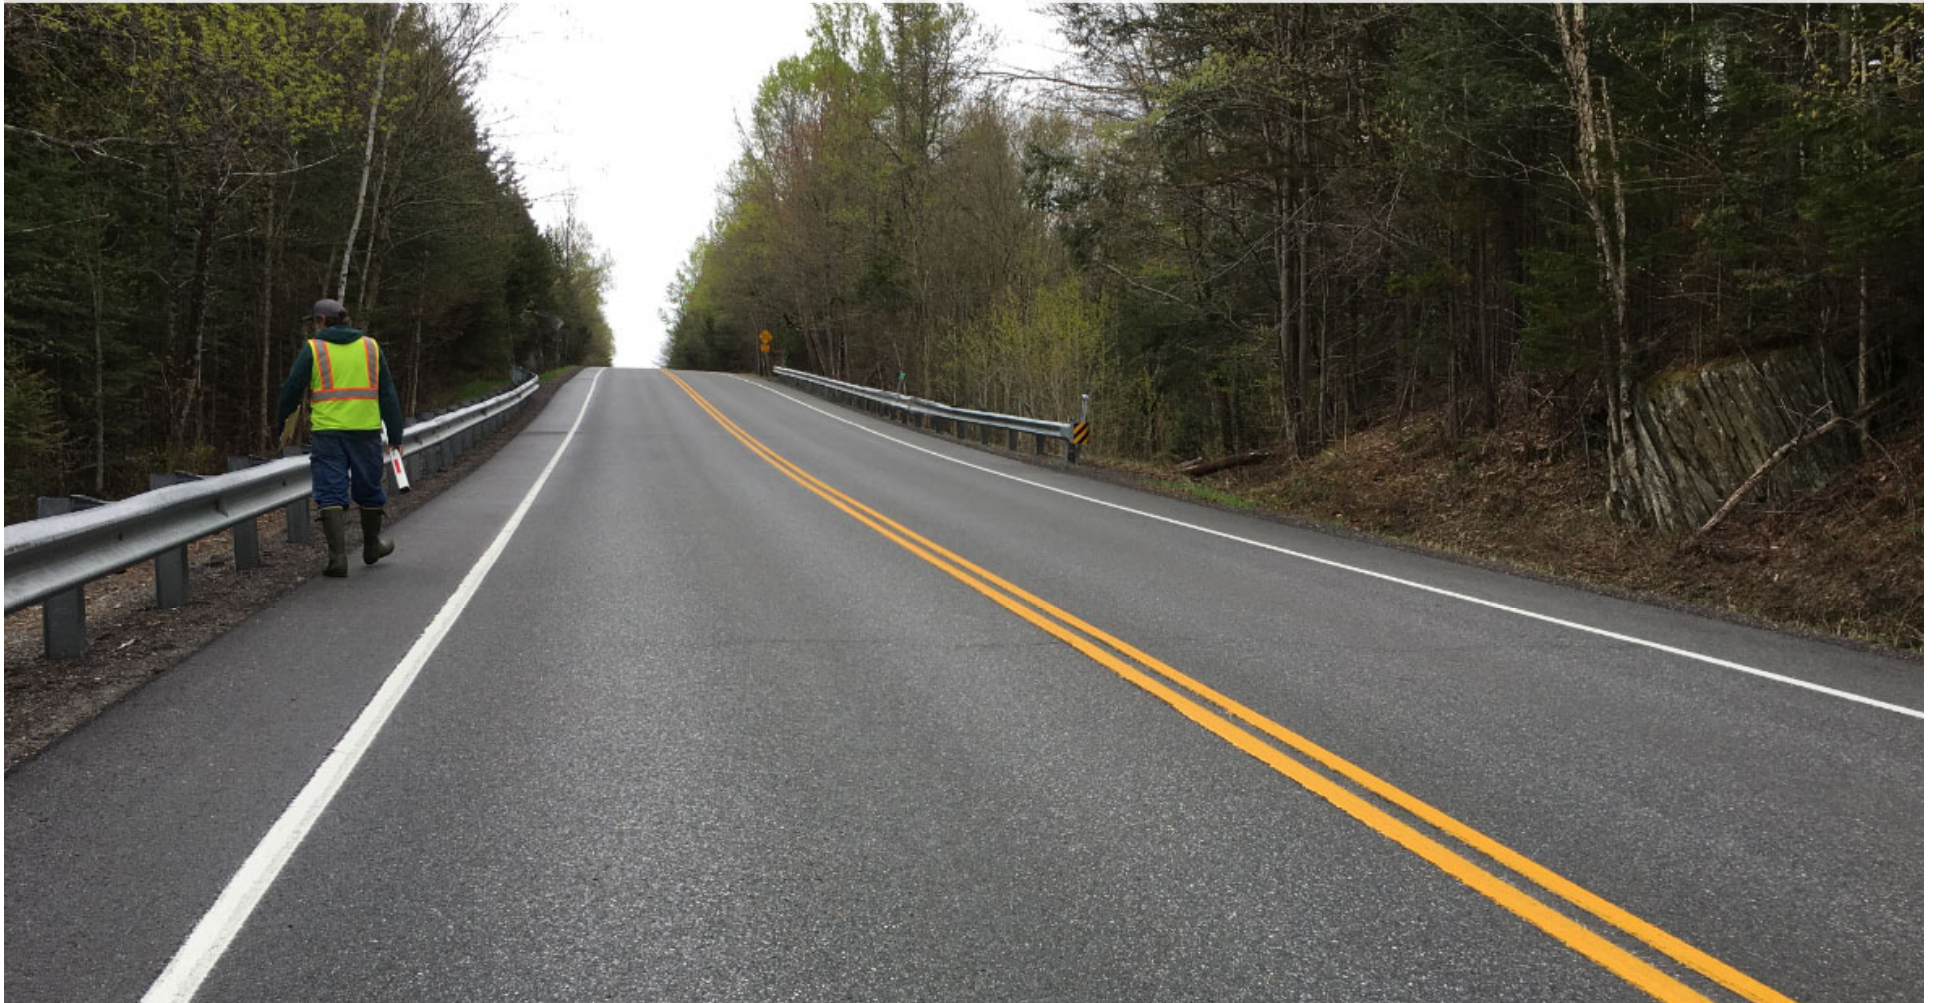
Existing Conditions – Bridge #90

- Steep slopes upstream and downstream
- Exposed Bedrock

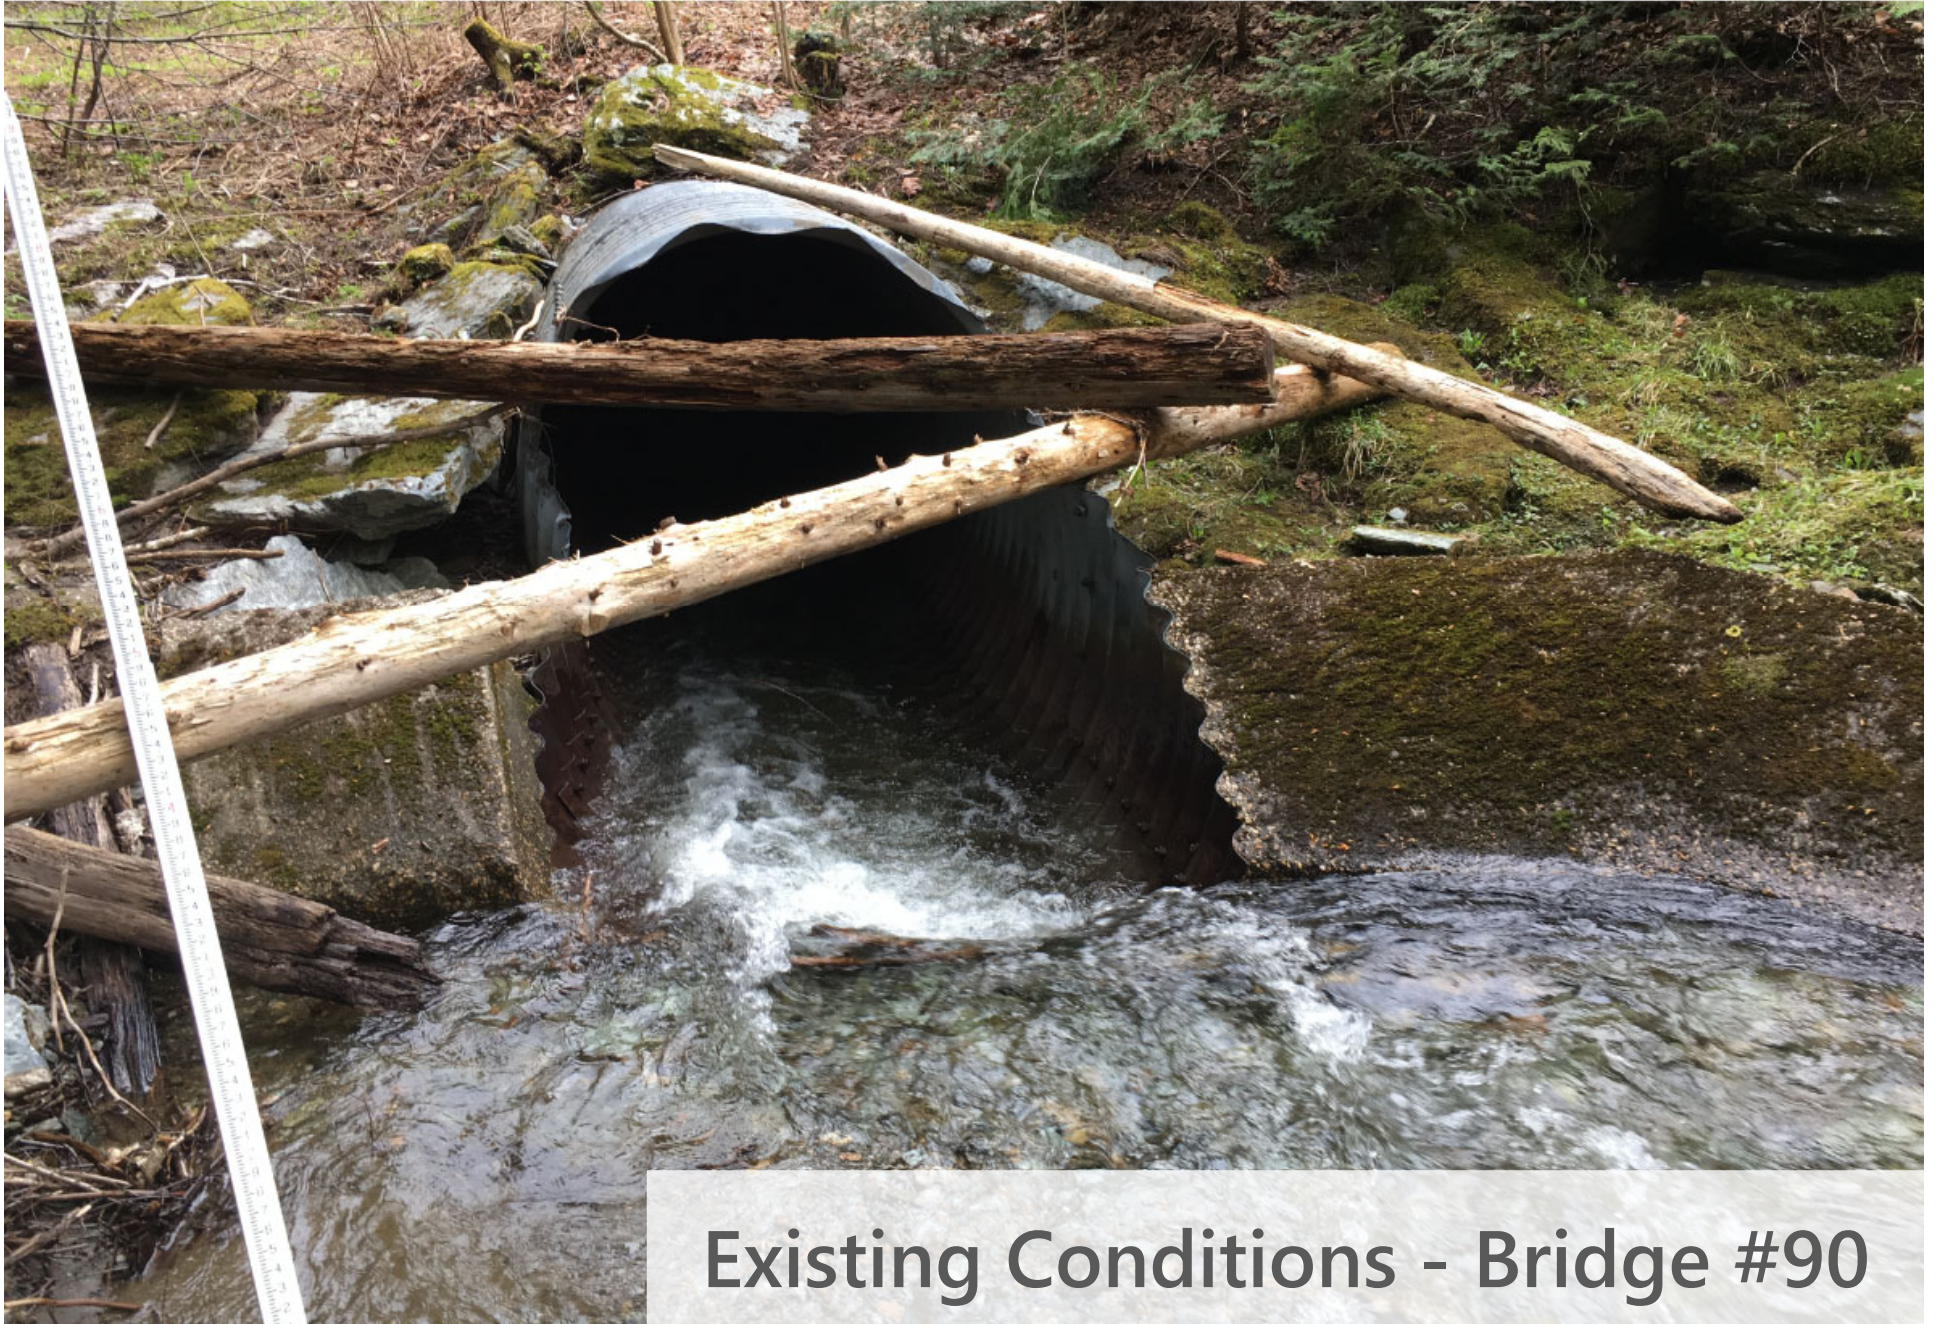
Inlet

- The culvert is in serious condition.
 - There is heavy rust scaling and holes throughout the invert.
 - The pipe has buckled under the roadway and cracks have formed.
- The existing culvert does not meet the calculated or measured bank full width (23') and does not meet the minimum hydraulic standard.

- Culvert Rating 3 (Serious)

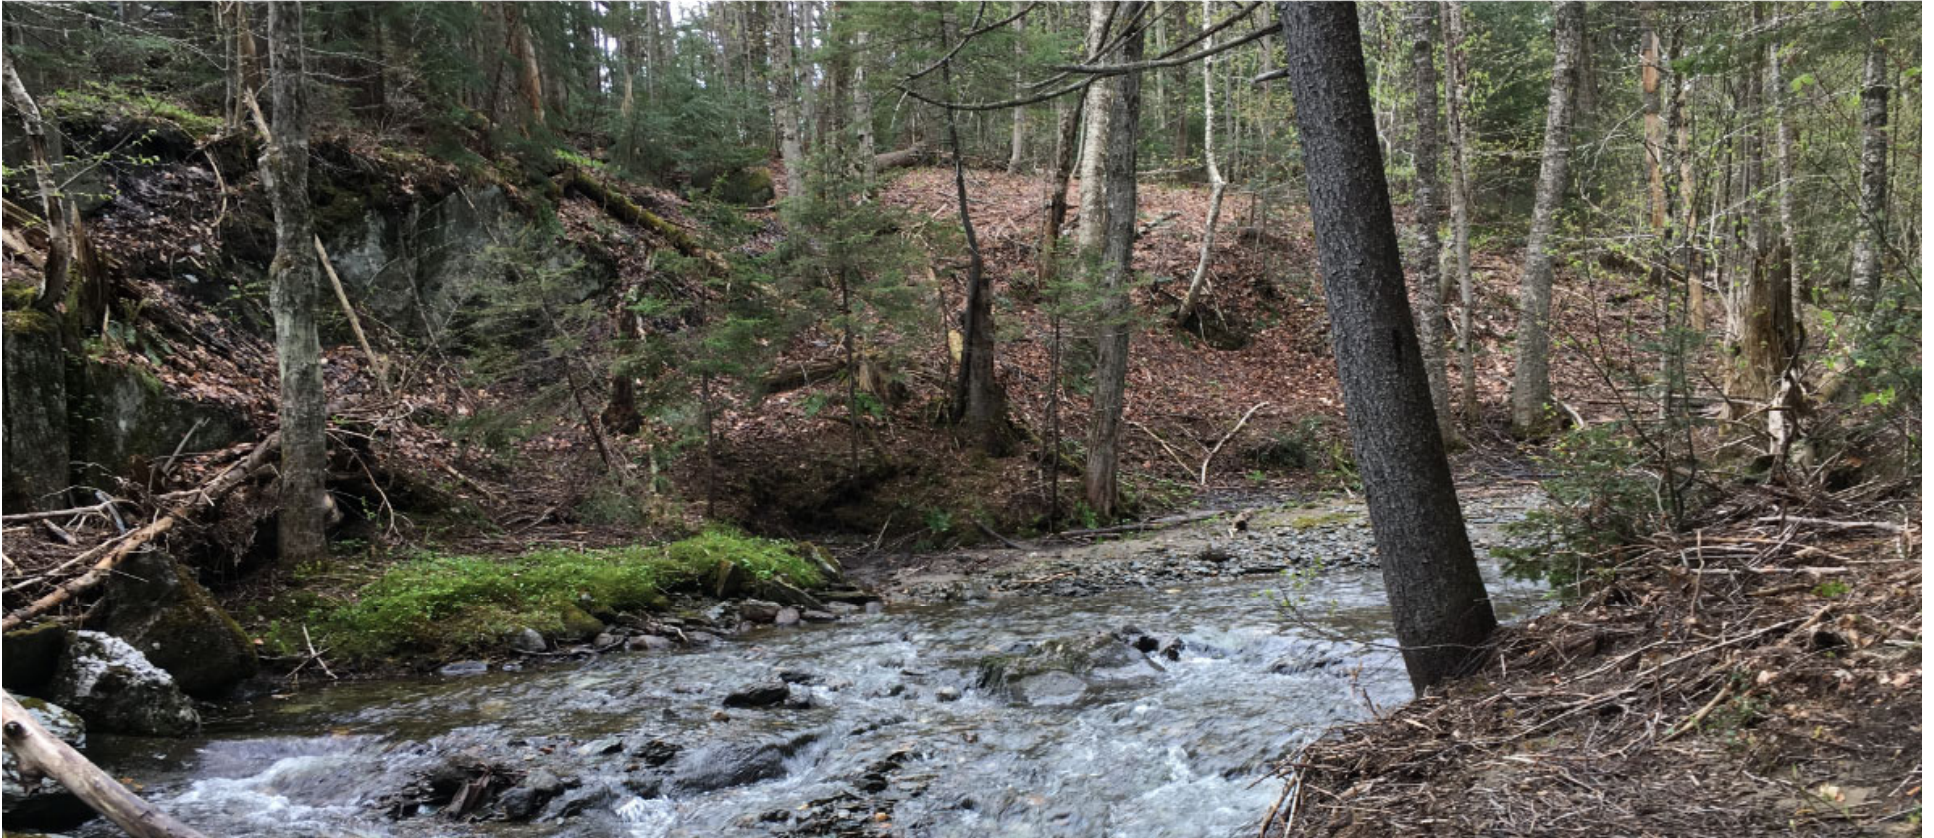
Resources – Looking Upstream

Existing Conditions – Bridge #90

- Northern Long-Eared Bat
- Wetlands
- Statewide significant agricultural soils and prime agricultural soils
- Wildlife Habitat

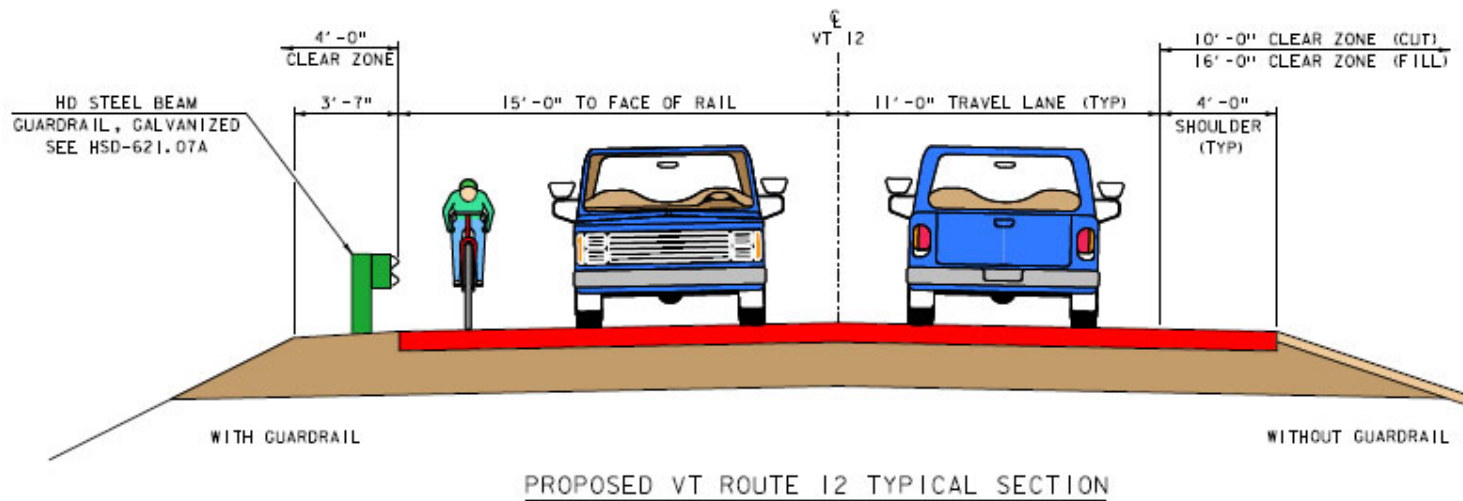
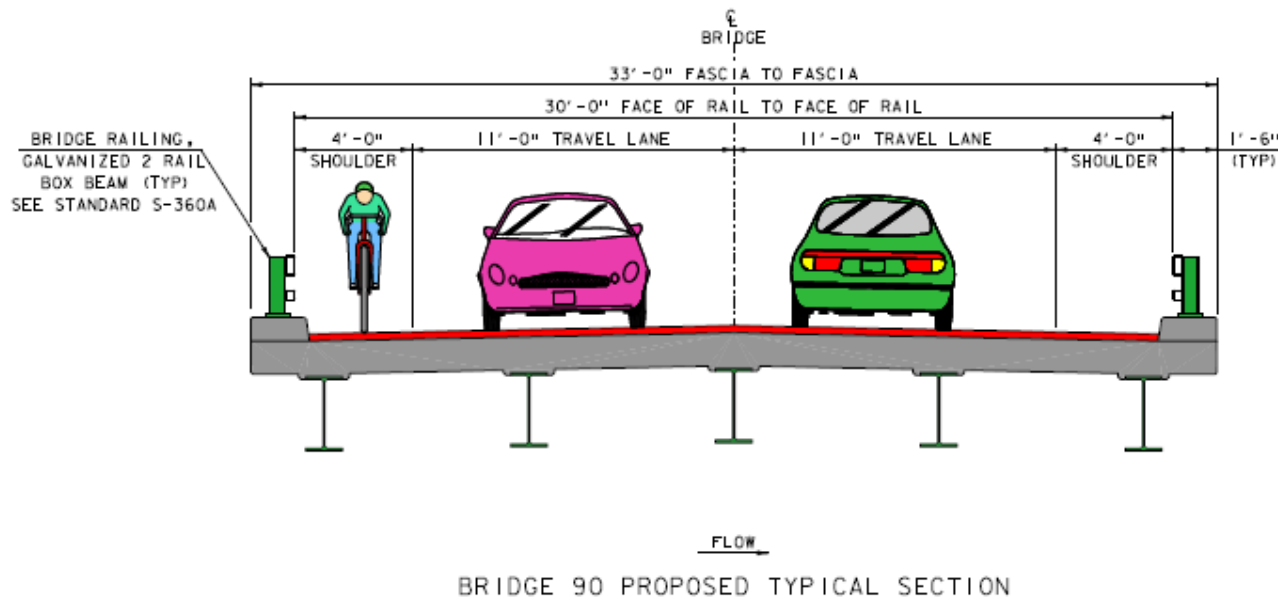
Proposed Typical Section

- Culvert Replacement with a New Bridge and One Lane Alternating Traffic Maintained on a Temporary Bridge
 - Substructure contingent on borings
 - Approximate 60' to 80' Span
 - 11'¼' typical to match existing conditions
 - Exceeds the 11'⅓' standard typical section
 - 75-year design life
 - Right of Way needed for temporary bridge and slope limits

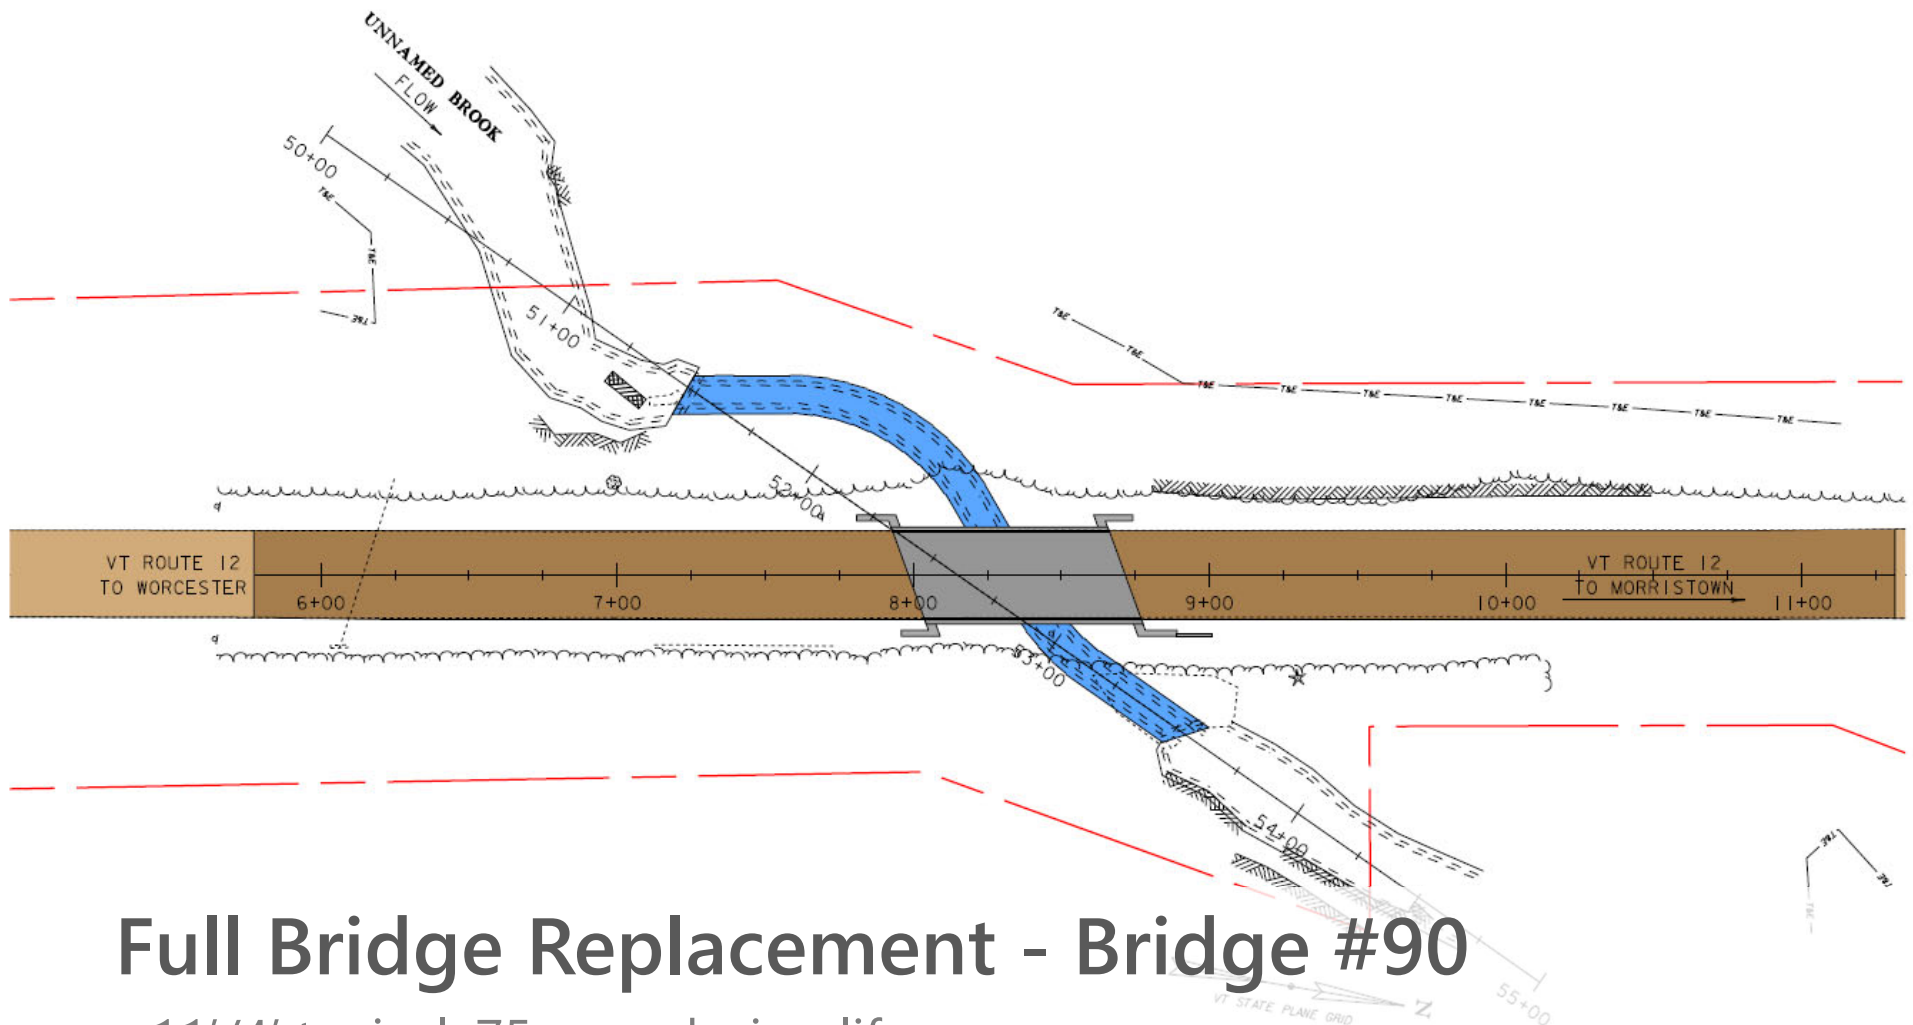
Proposed Layout

Full Bridge Replacement - Bridge #90

- 11'¼' typical, 75-year design life
- Approximate 60' to 80' Span
- Stream to be re-established back to natural state

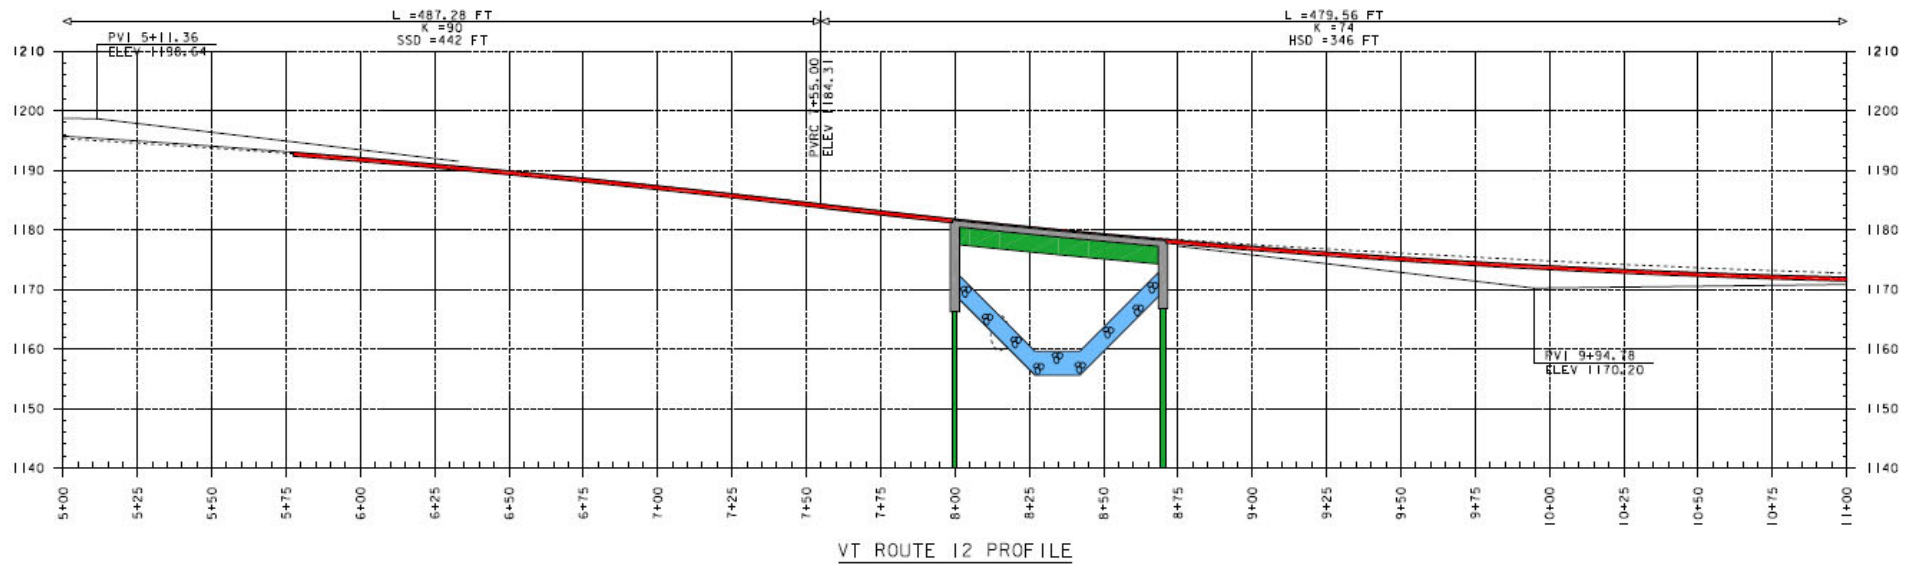
Proposed Profile

New Bridge - Bridge #90

- Match existing vertical grade
- Improved wildlife crossing

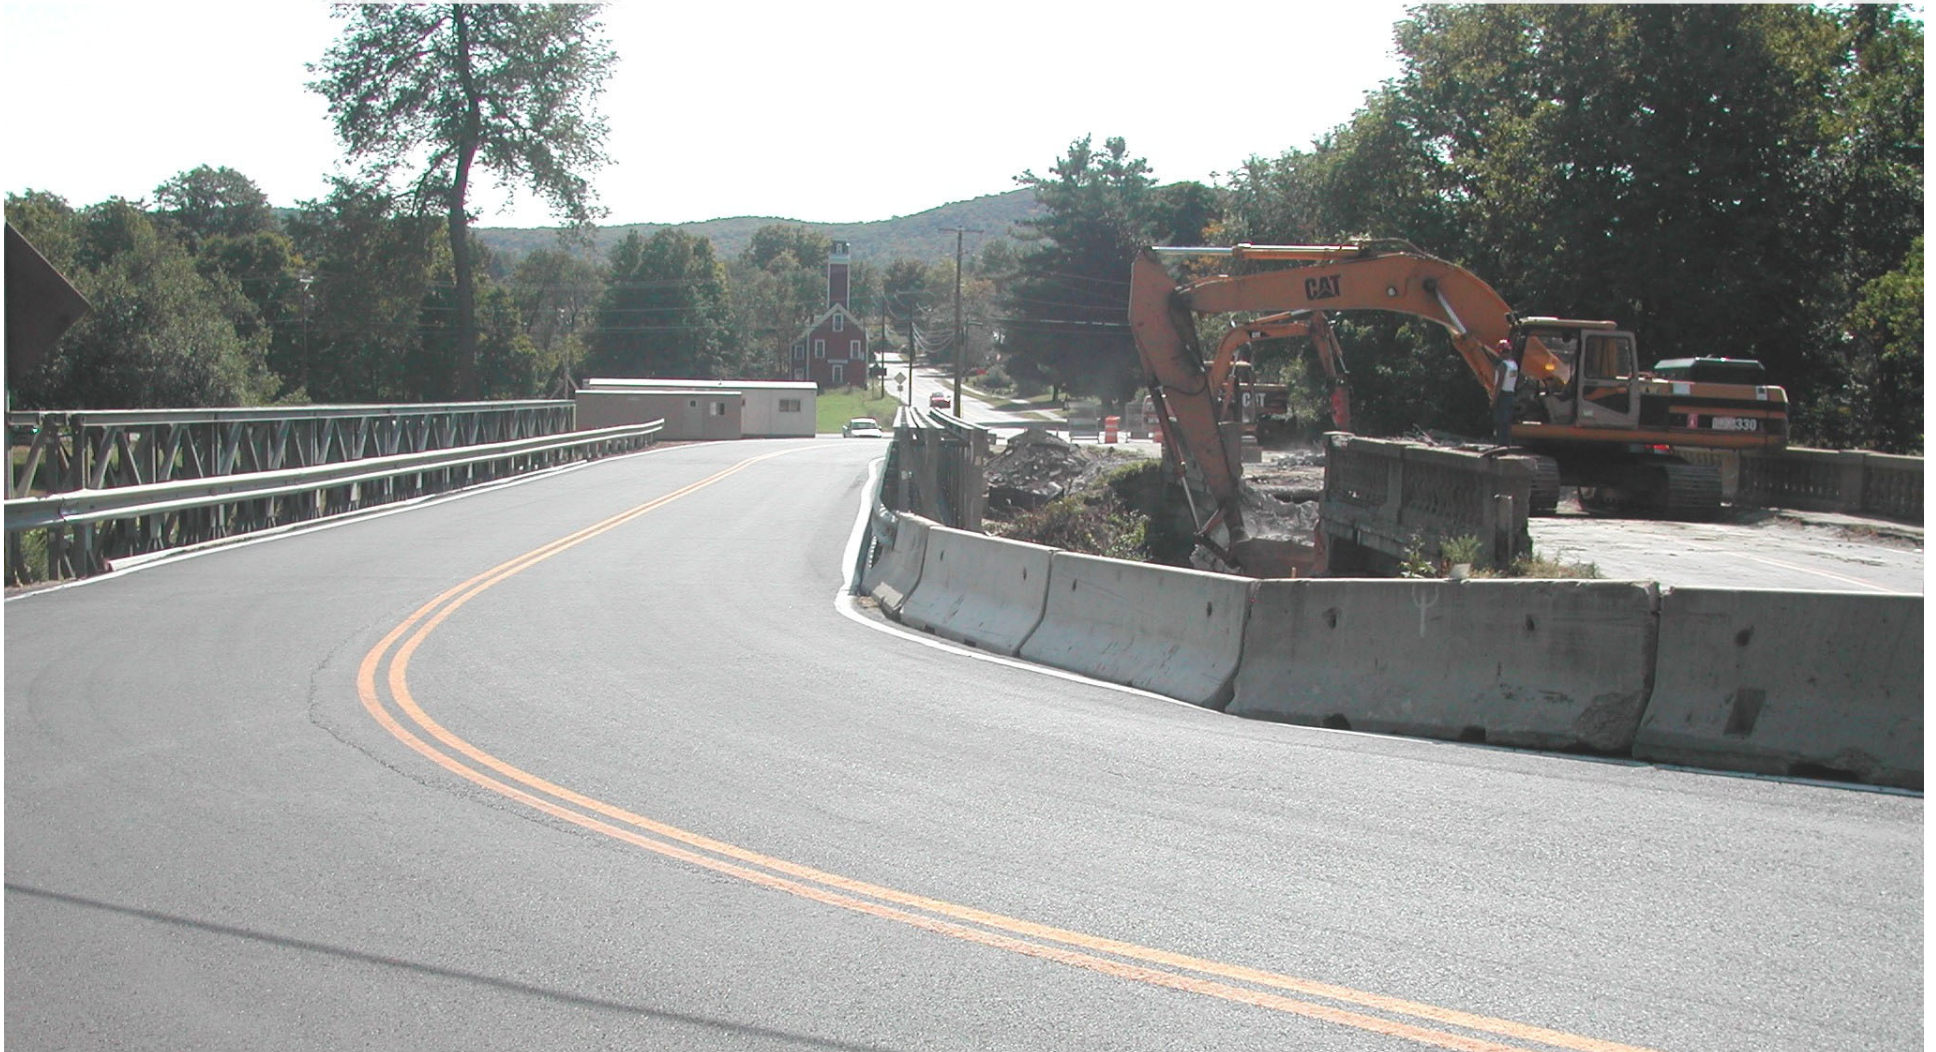
Selected Method of Traffic Maintenance

Temporary Bridge

- One Lane Temporary Bridge constructed on Downstream side of VT Route 12

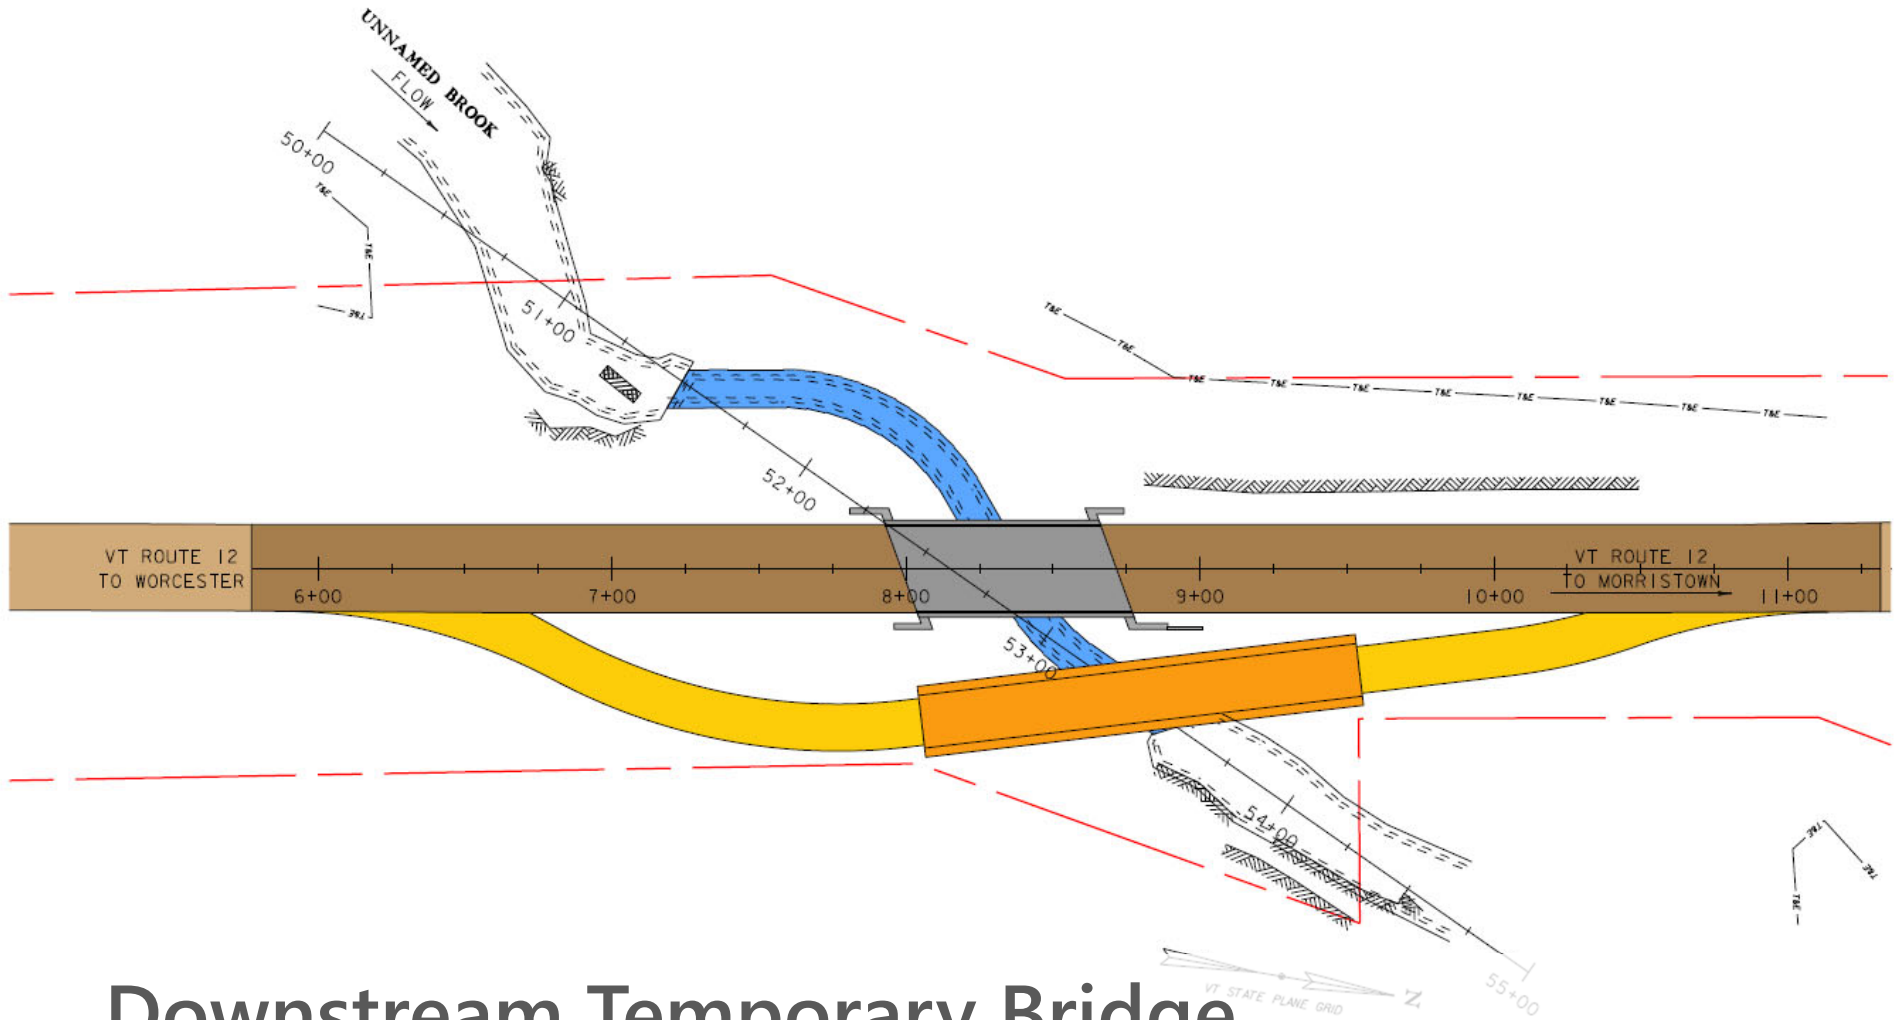
Downstream Temporary Bridge Layout

Downstream Temporary Bridge

- Potential limits outside the Right-of-Way
- Avoids ledge outcrop in NW quadrant

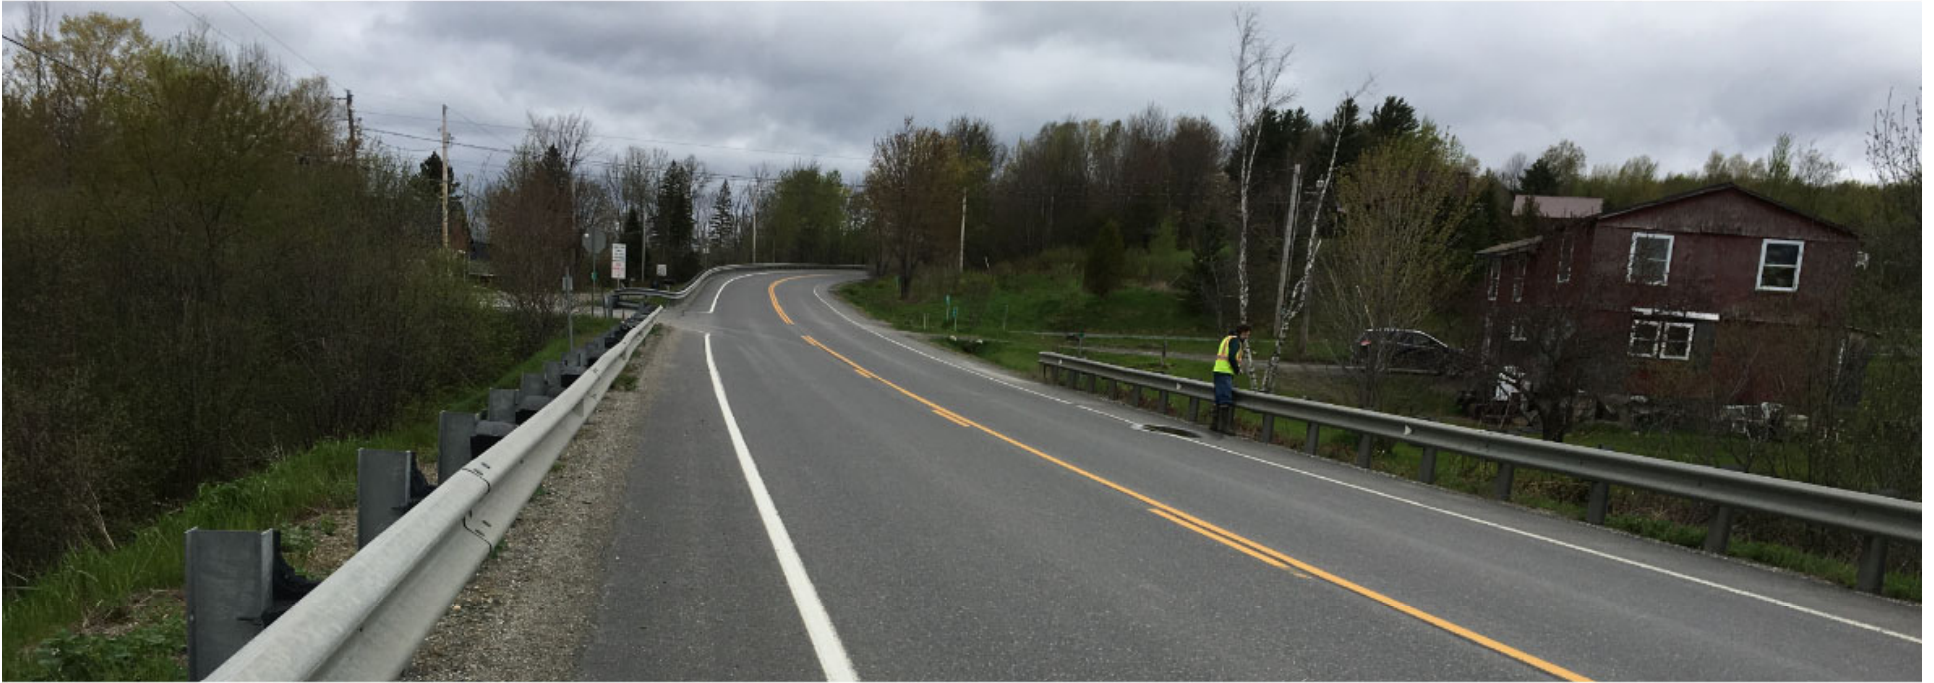
Existing Conditions – Bridge #94

- Roadway Classification – Major Collector
- Bridge Type – 6' Span ACCGMPP (Aluminum Coated Corrugated Galvanized Metal Plate Pipe)
- Culvert Length – 74 feet
- Fill Over Culvert – 10 feet
- Ownership – State of Vermont
- Constructed in 1959

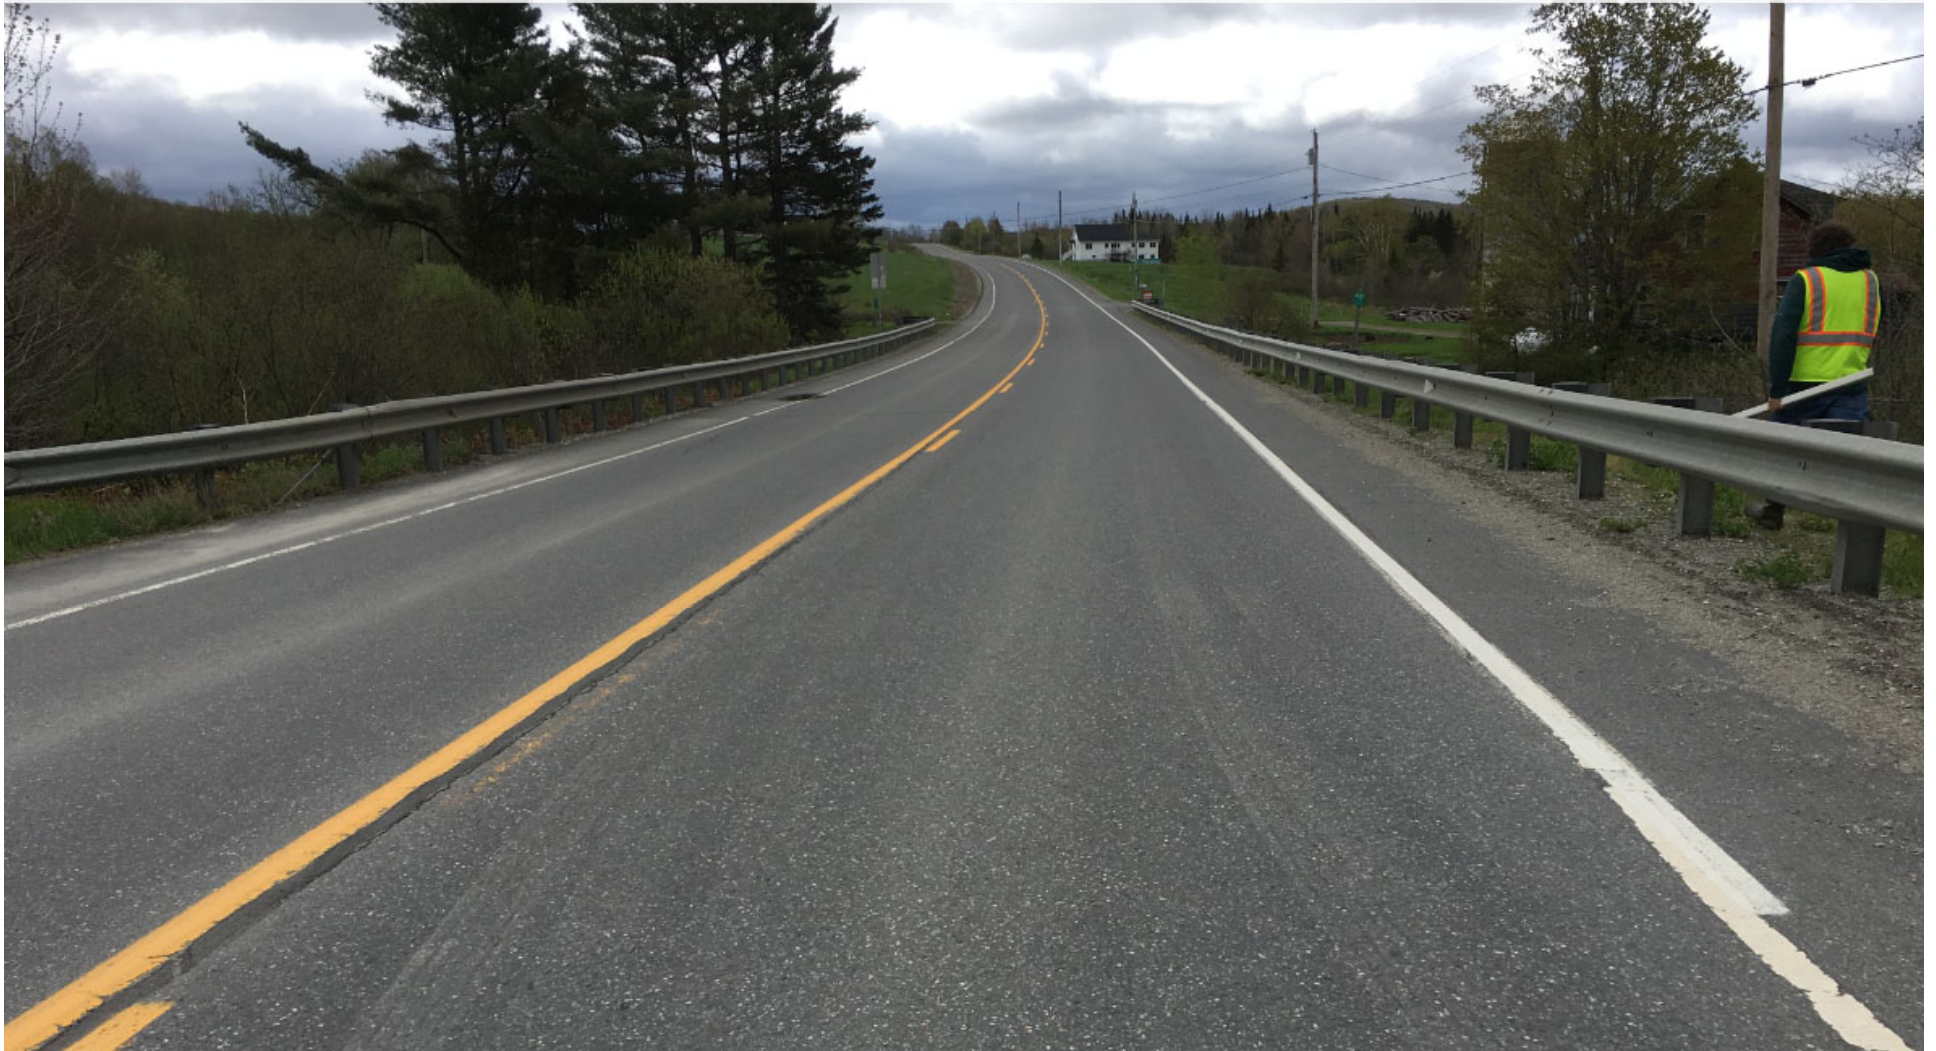
Existing Conditions – Bridge #94

- Aerial Utilities
