TOWN OF ELMORE, VT

Monthly Select Board Meeting

WE12 - Worcester Elmore VT Route 12 Public Informational Meeting

VT Route 12 – Elmore Bridges #90 & 94

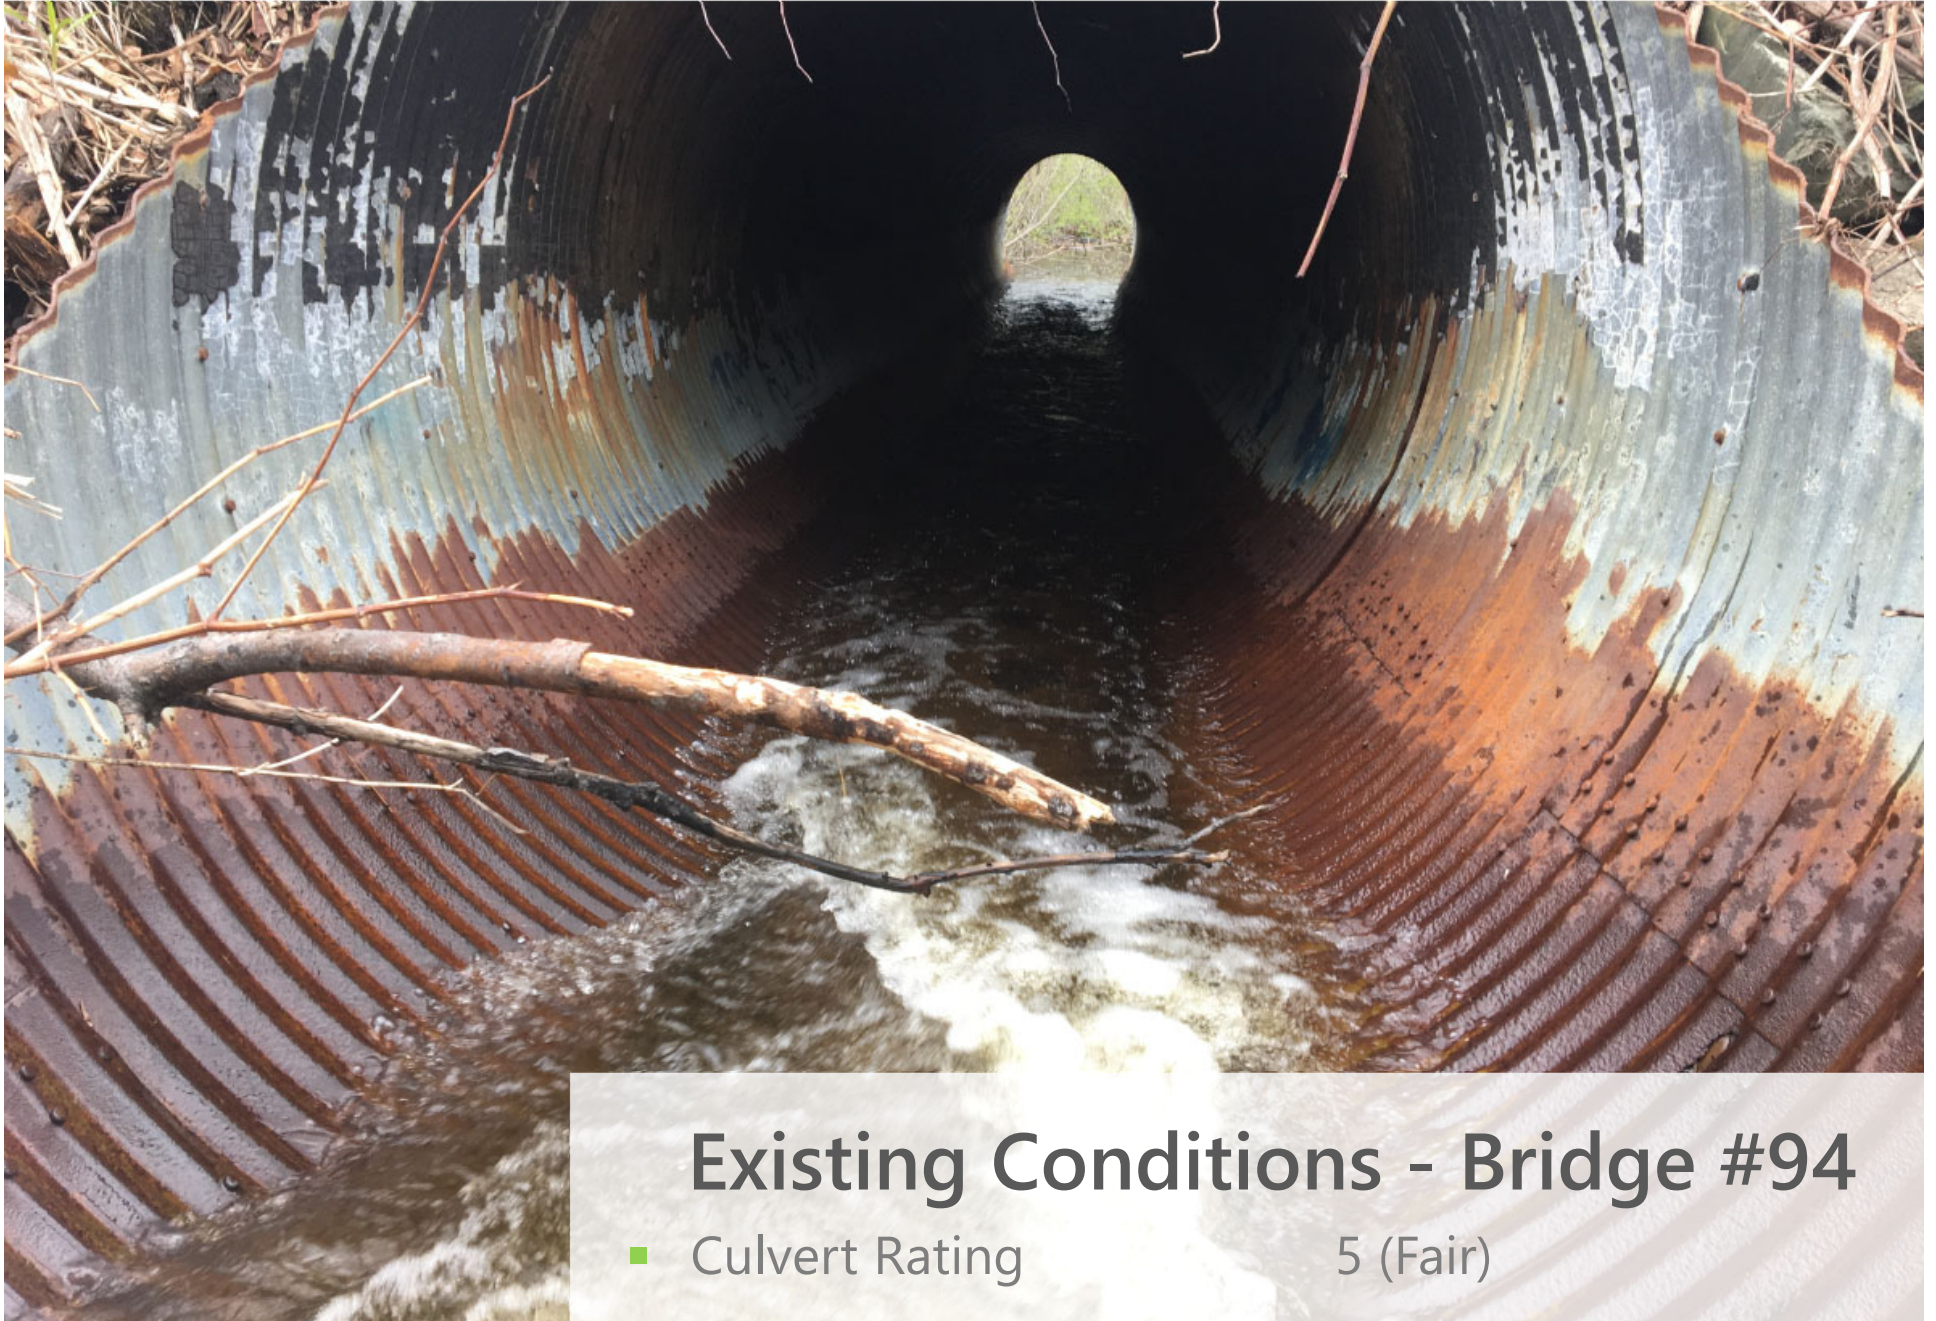
Condition Ratings

- The culvert is in fair condition.
 - There are holes throughout the invert up to 2-inches in diameter.
 - The asphalt coating is wearing off.
 - The outlet of the pipe has moved up causing some deflection in the culvert.
- The vertical alignment along VT Route 12 through the project area has a slightly substandard sag curve.
- The existing culvert does not meet the calculated or measured bank full width (11').

■ Culvert Rating

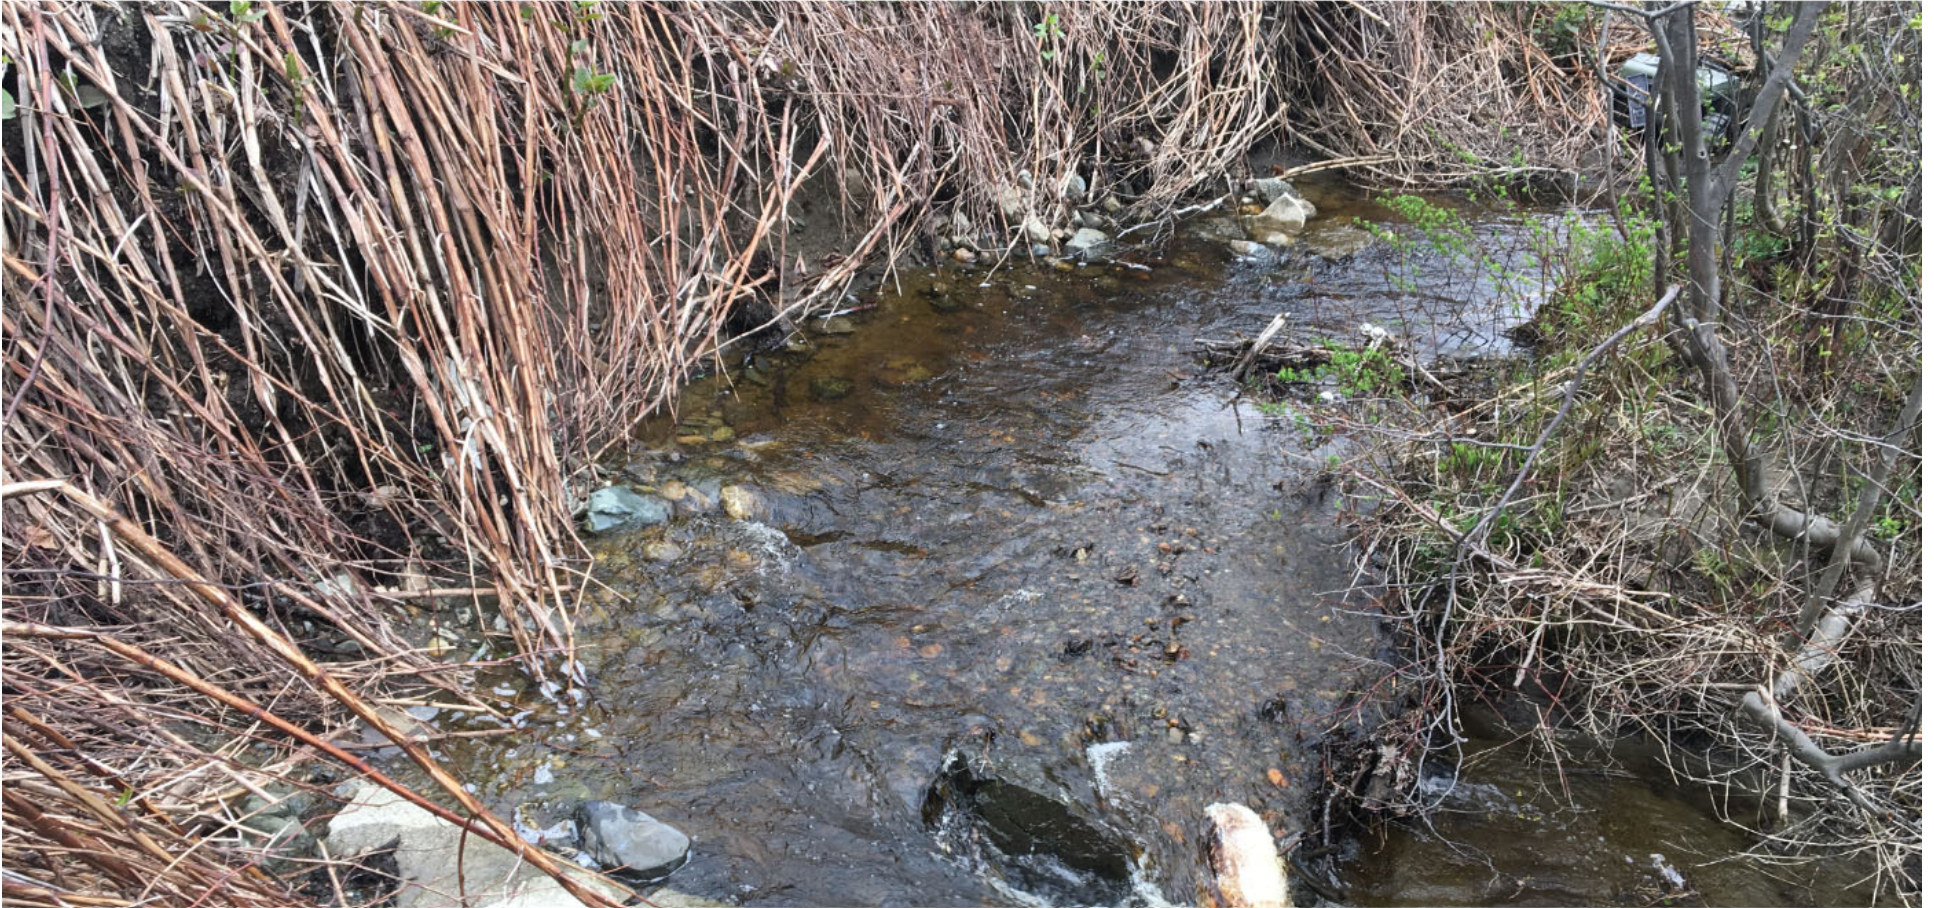
Resources – Looking Upstream

Existing Conditions – Bridge #94

- Northern Long-Eared Bat
- Wetlands
- Archaeological Resources
- Primary agricultural soils
- Wildlife Habitat
- Scour along banks

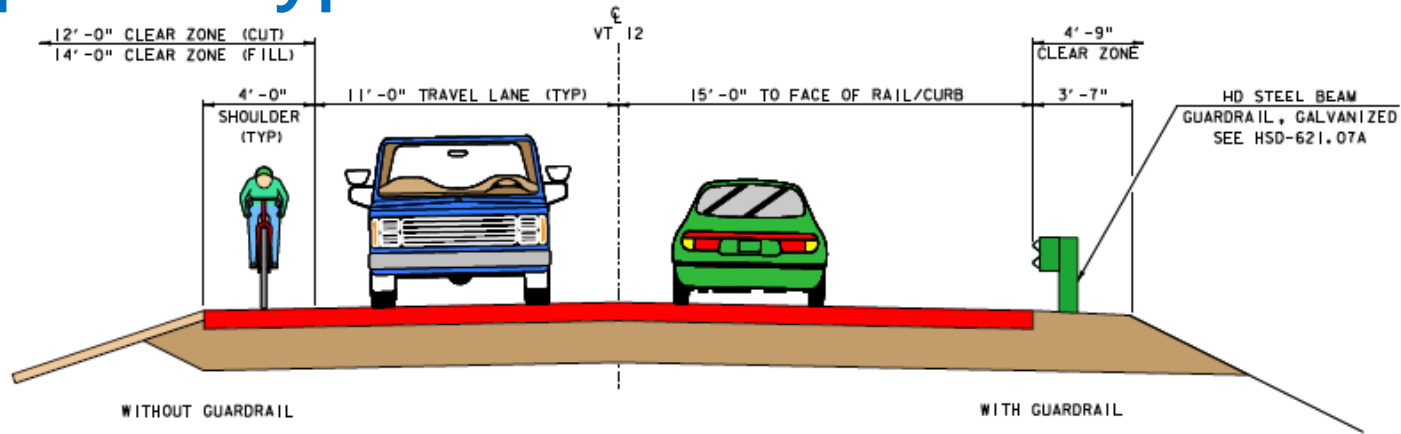
PROPOSED VT ROUTE 12 TYPICAL SECTION

- Culvert Replacement with a New Buried Structure
 - Precast Concrete Box
 - Contingent on borings
 - 11' x 10' box with Type E4 Stone
 - 11' x 6' waterway opening
 - 75' Culvert Length
 - 11'¼' typical to match existing conditions
 - Exceeds the 11'⅓' standard typical section
 - 75-year design life

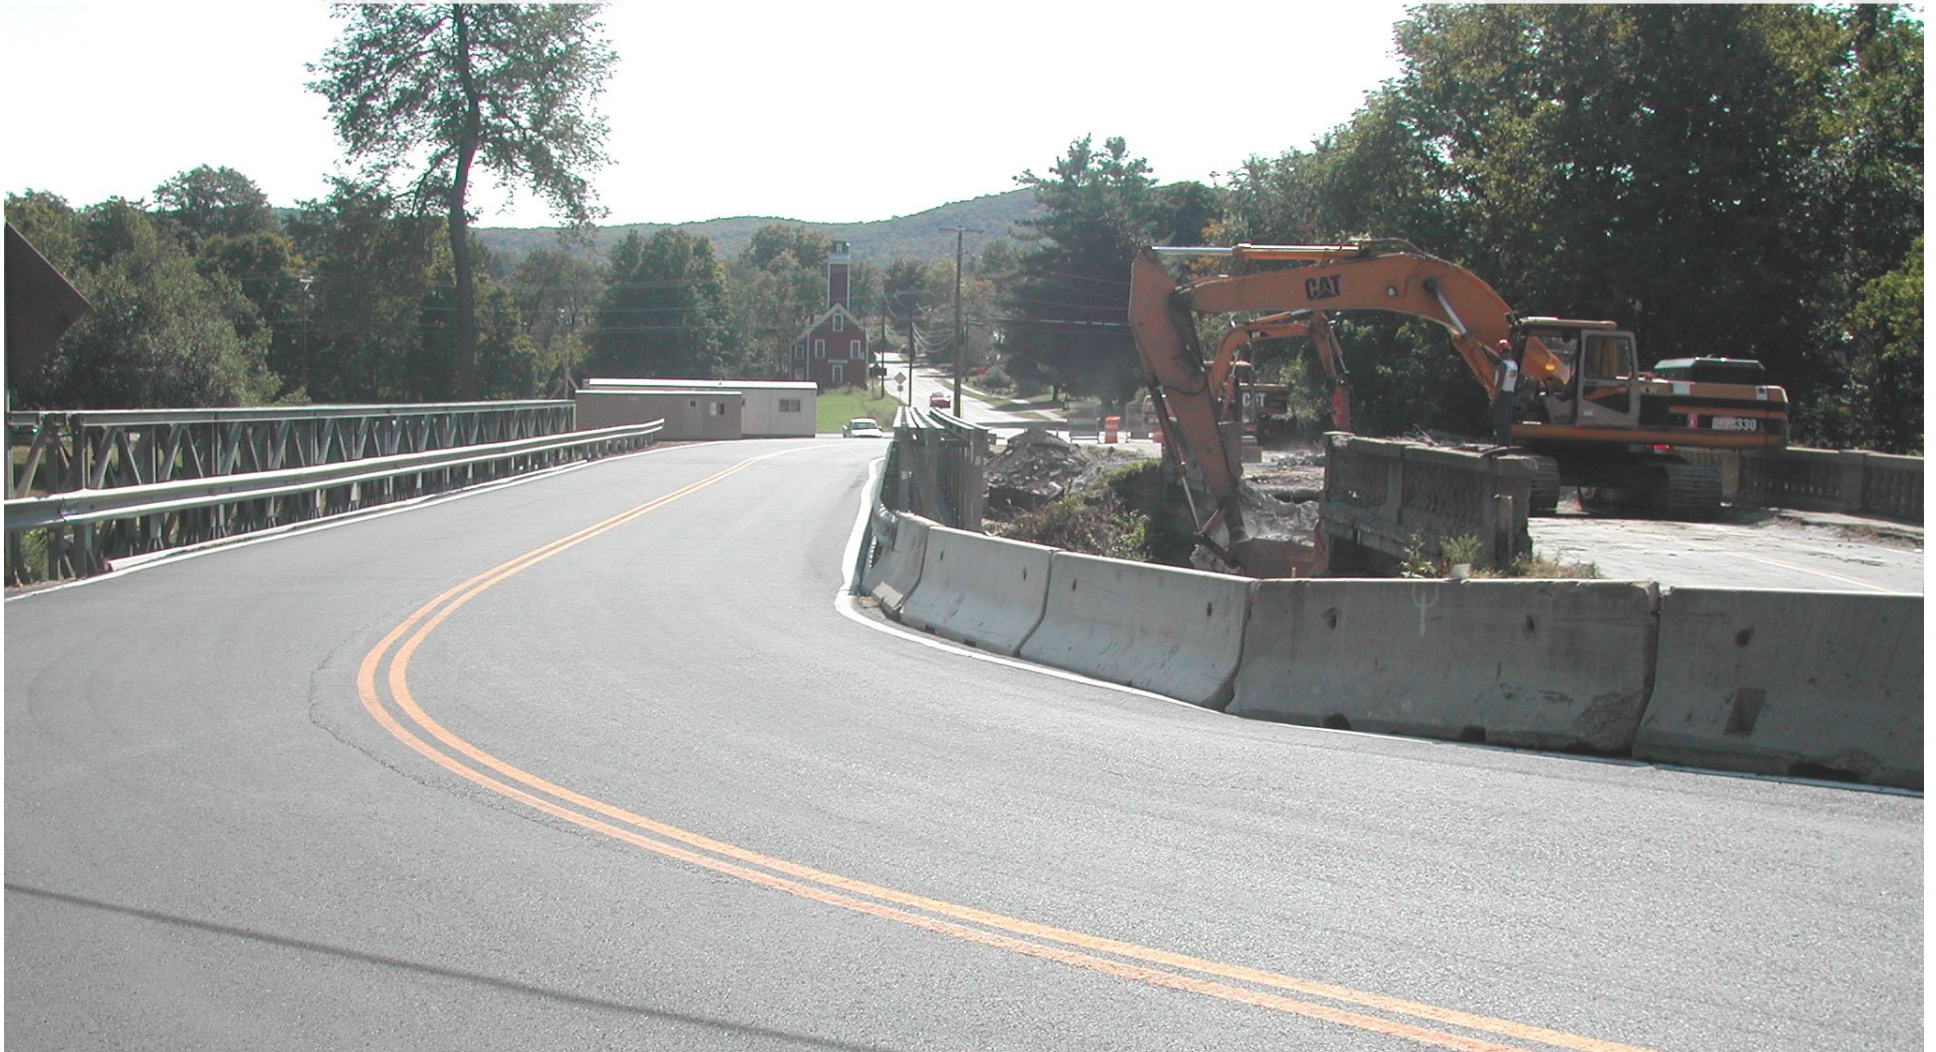
Selected Method of Traffic Maintenance

Temporary Bridge

- One Lane Temporary Bridge constructed on Downstream side of VT Route 12

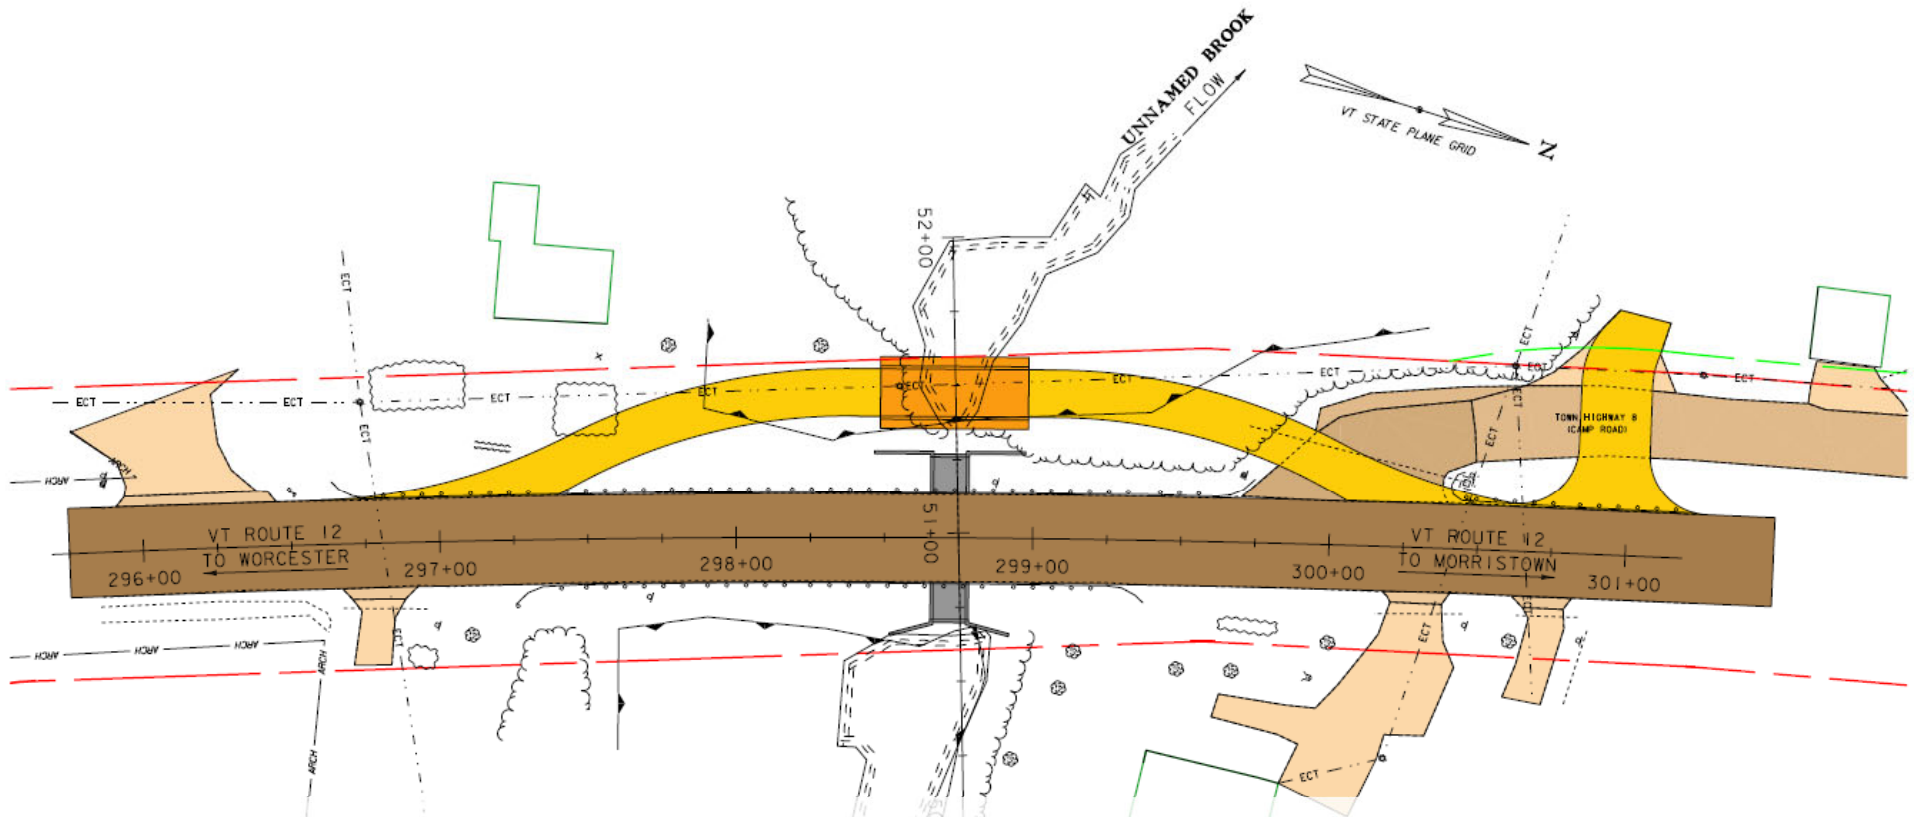
Downstream Temporary Bridge Layout

Downstream Temporary Bridge

- Aerial utilities located on downstream side
- Camp Road intersection impacts
- Wetland area impacted
- More State-Owned Right-of-Way on downstream side
